Re: Riverbank Sampling — Operable Unit 1
Swan Island Upland Facility
Portland, Oregon
ECSI No. 271
1115-06

Riverbank Sampling Letter Report
Swan Island Upland Facility Operable Unit 1
Portland, Oregon

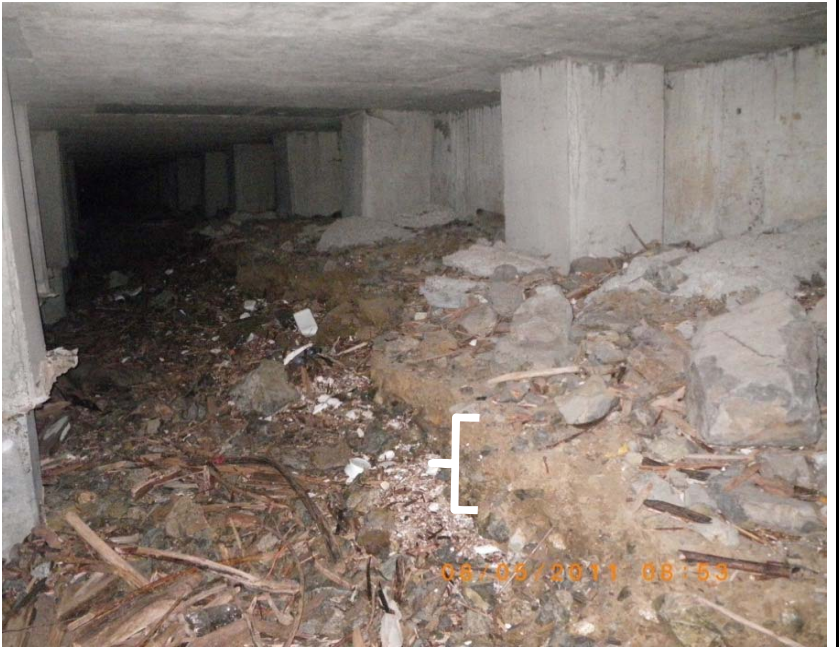
Photo No: 1

- Y – Erosion scarp. The scarp is above the OLHW, approximately 100 feet long and 1 foot high. The scarp is comprised of cemented sand and riprap.
- Z – Erosion scarp. The scarp is above the OLHW, approximately 65 feet long and 1 foot high. The scarp is comprised of cemented sand and riprap.

Photo Date: 8/5/2011	
Orientation: Northwest	
Description: Feature Z - White bracket highlights scarp face.	
Photo No: 2	 
Photo Date: 8/22/2012	
Orientation: Northeast	
Description: Vicinity of Feature X showing exposed sheet-pile bulkhead wall.

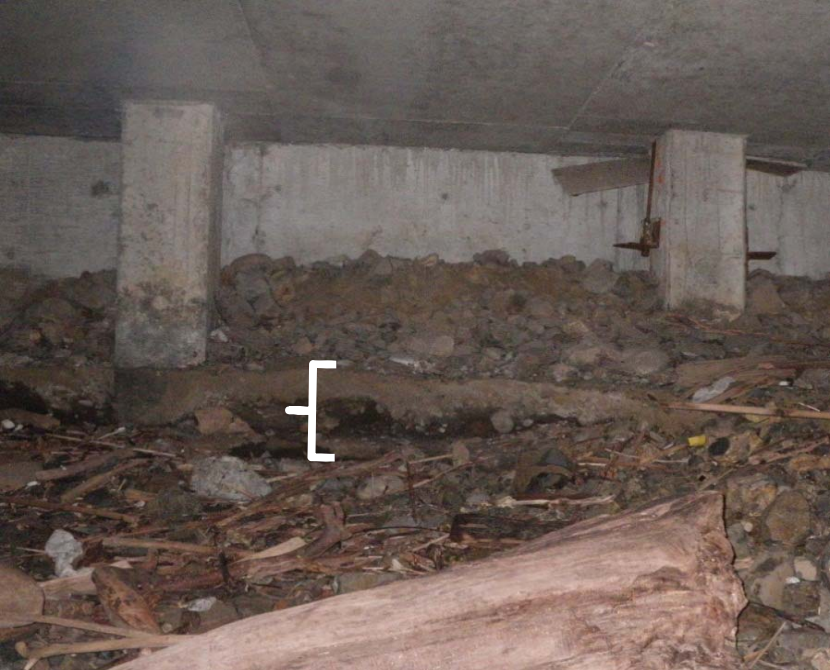
Photo No: 3

- R – Erosion scarp. The scarp is above the OLHW, approximately 15 feet long and 1 foot high. The scarp is comprised of cemented sand and riprap.
- S – Erosion scarp. The scarp is above the OLHW, approximately 135 feet long and 1 foot high. The scarp is comprised of cemented sand and riprap.

Photo Date: 8/22/2012	
Orientation: Northeast	
Description: Feature S - White bracket highlights scarp face.	
Photo No: 4

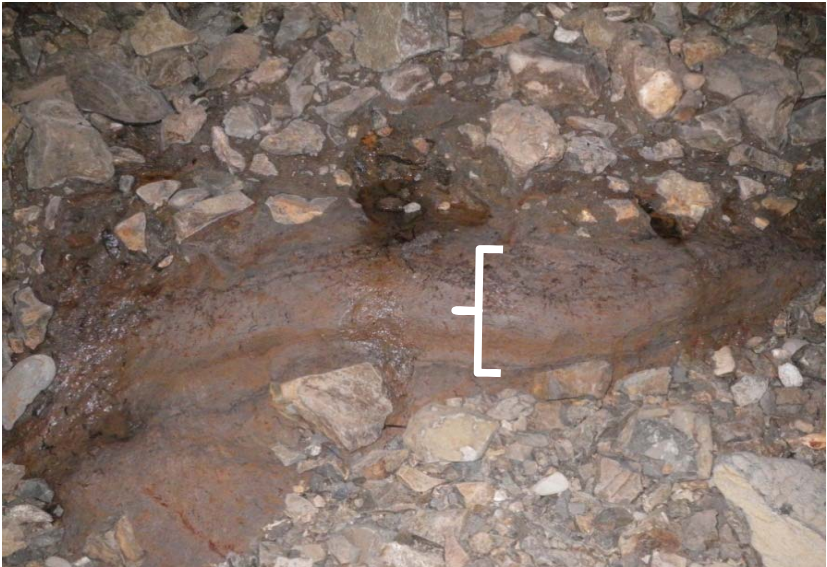
- O – Small exposed silt bench below OLHW.
- P – Erosion scarp. The scarp is above the OLHW, approximately 15 feet long, and 1 to 1.5 feet high. The scarp is comprised of cemented sand and riprap. This feature trends from the back sheet-pile bulkhead, which is exposed at the west end of the scarp.

Photo Date: 8/22/2012	
Orientation: Northeast	
Description: Feature O - White bracket highlights scarp face.

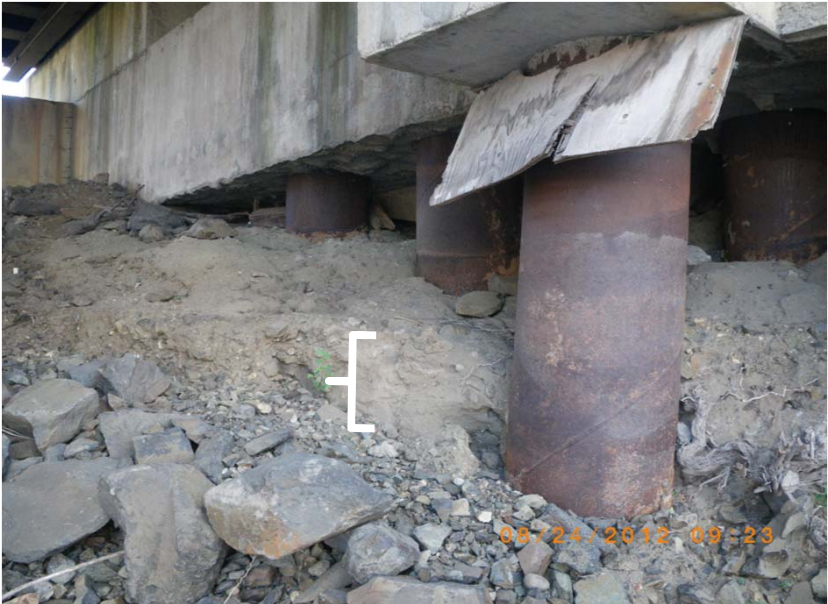
- AC – Erosion scarp. The scarp is above the OLHW, approximately 60 feet long and 1 to 2 feet high. The scarp is comprised of cemented sand and riprap and extends from under the river side dock. Sample OU1-RB11 was collected from this feature.

Photo Date: 8/24/2012	
Orientation: East	
Description: Feature AC - White bracket highlights scarp face.

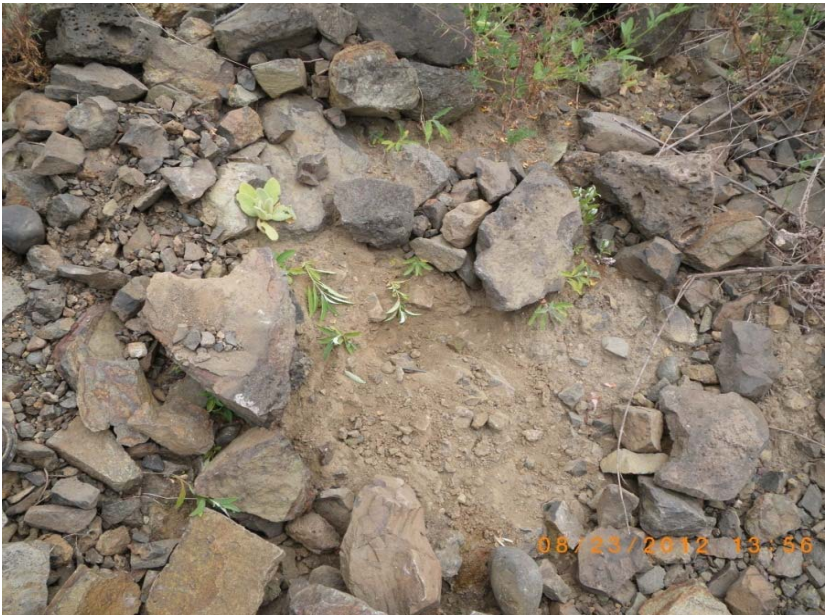
Photo No: 12

- AG – Erosion scarp. The scarp is above the OLHW, approximately 30 feet long and 2 to 3 feet high. The scarp is comprised of dense sand and riprap.
- AH – Bare soil. Exposed and bare soil within riprap armoring. This feature is approximately 30 feet in length and extends upslope from the OLHW. Sample OU1-RB14 was collected from this feature.

Photo Date: 8/23/2012	
Orientation: Southeast	
Description: Feature AH

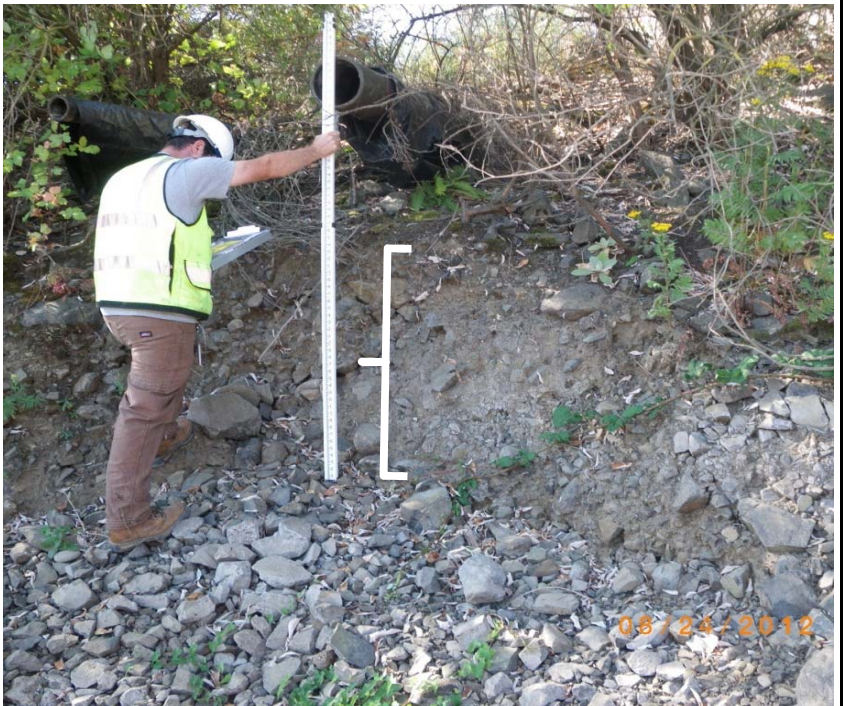
Photo No: 14

- AK – Erosion scarp. The scarp is above the OLHW, approximately 20 feet long and 3 inches high.
- AL – Erosion scarp. The scarp is above the OLHW, approximately 25 feet long, and 3 to 4 feet high. The scarp is comprised of sand, gravel, and cemented riprap. This feature is located below two small-diameter outfalls (4 and 8 inches in diameter), but it is unclear if these outfalls are active. Sample OU1-RB16 was collected from this erosional feature.

Photo Date: 8/24/2012	
Orientation: Southeast	
Description: Feature AL - White bracket highlights scarp face.

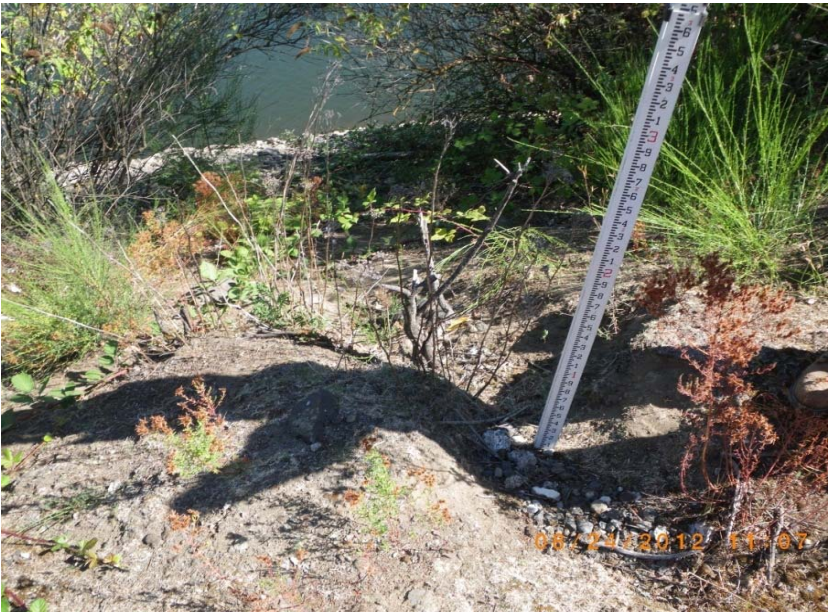
Photo No: 15

- AM – Erosion scarp. The scarp is predominantly above the OLHW, approximately 40 feet long, and 2 to 3 inches high.
- AN – Erosion rills. Small, 1- to 2-foot-wide erosional rills extending from the wide flat bench, downslope to the riverbank. Most of these features are located under vegetative cover.

Photo Date: 8/24/2012	
Orientation: Northeast	
Description: Feature AN - Example of erosion rill on riverbank slope.

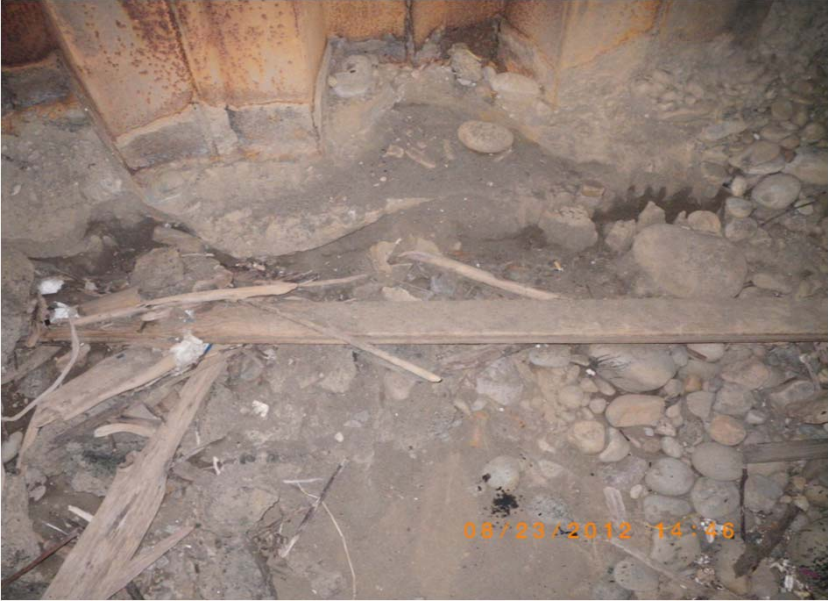
Photo No: 16

- Approximately ten locations were observed where a thin layer of sand was present on and surrounded by riprap (Photographs 16, 17, and 19). These areas were attributed to deposition during periods of high water. These areas were commonly observed on one or both sides of the bulkhead walls that separate the catwalk (i.e., locations where water slows down and allows for settling). These individual areas do not represent a significant volume of material and were therefore not sampled for laboratory analysis.

Photo Date: 8/23/2012	
Orientation: Southwest	
Description: Typical location with thin layer of sand present on and surrounded by riprap. Attributed to deposition during periods of high water. See also Photographs 17 and 19).

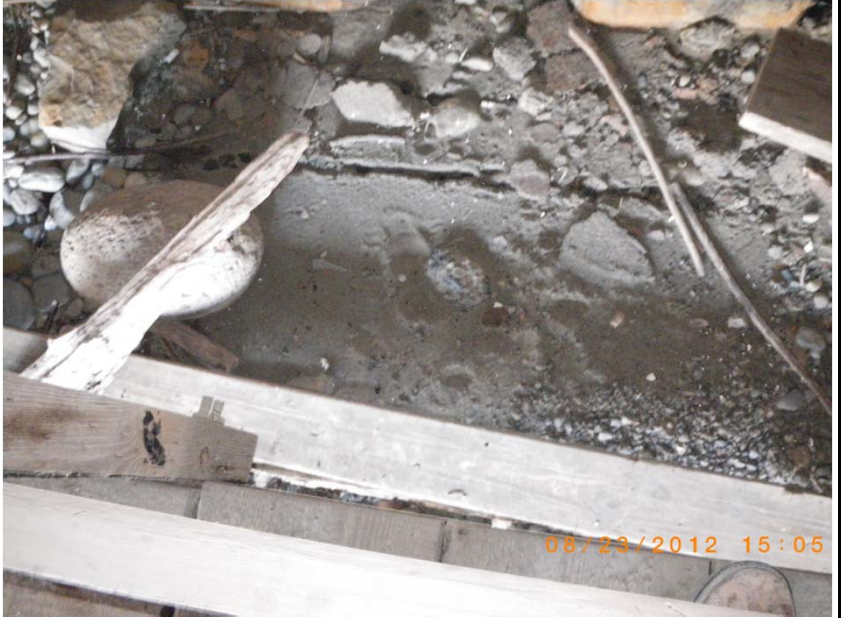
Photo No: 17

Photo Date: 8/23/2012	
Orientation: Southwest	
Description: Typical location with thin layer of sand present on and surrounded by riprap. Attributed to deposition during periods of high water. See also Photographs 16 and 19).

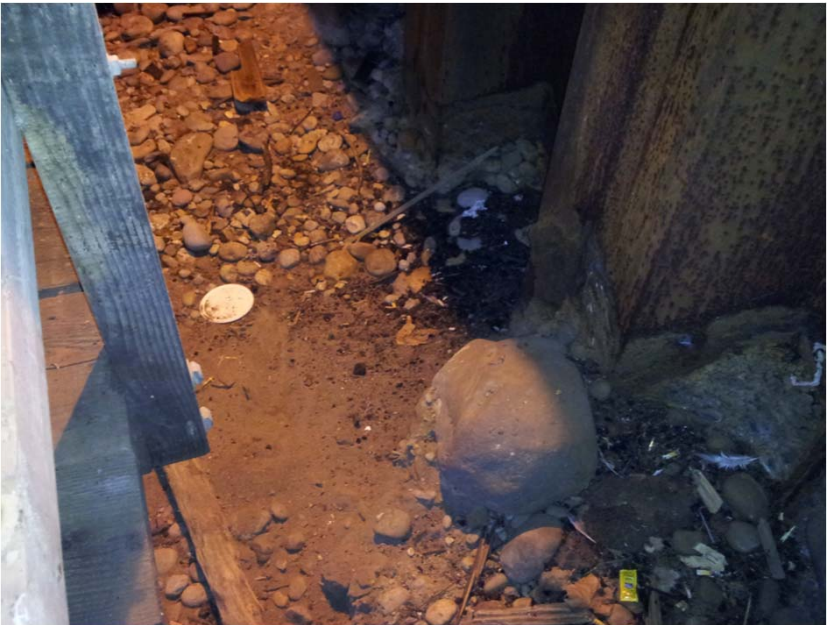
Photo No: 19

Photo Date: 8/24/2012	
Orientation: South	
Description: Typical location with thin layer of sand present on and surrounded by riprap. Attributed to deposition during periods of high water. See also Photographs 16 and 17).	
Photo No: 20

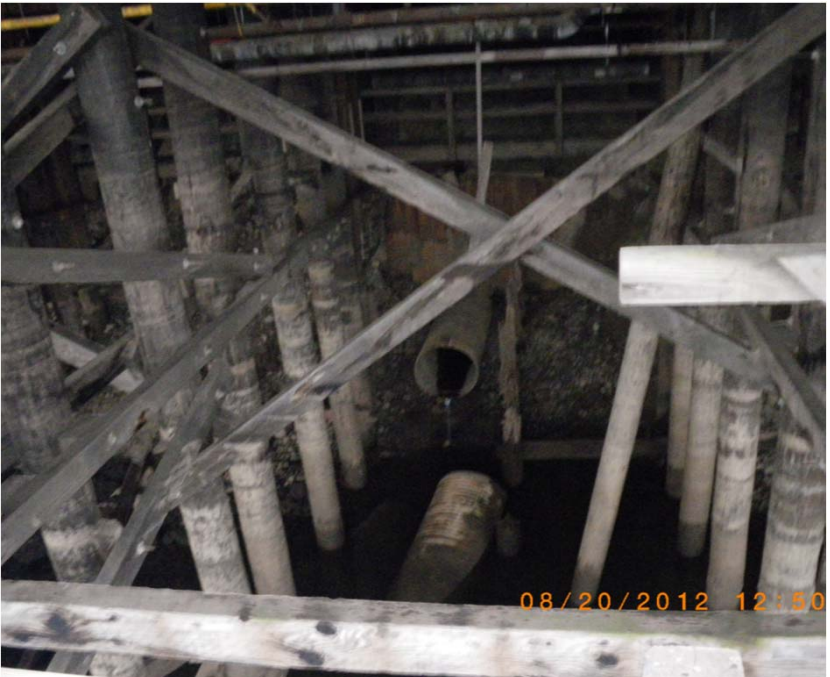
- AQ – Erosion scarp. The scarp extends from below the OLHW in the vicinity of a 36-inch corrugated metal outfall where the outer segment of the outfall pipe has become disconnected. The riverbank under the outfall forms a small cove. The scarp extends upslope beyond a small metal sheet-pile bulkhead. The scarp is comprised of loose silty sand with occasional gravels, and measures approximately 20 to 25 feet in length. Sample OU1-RB18 was collected from the face of this scarp.

Photo Date: 8/20/2012	
Orientation: Southwest	
Description: Feature AQ - Taken from outer catwalk. Disconnected section of outfall pipe in bottom center of photograph. See photographs 21 and 22.

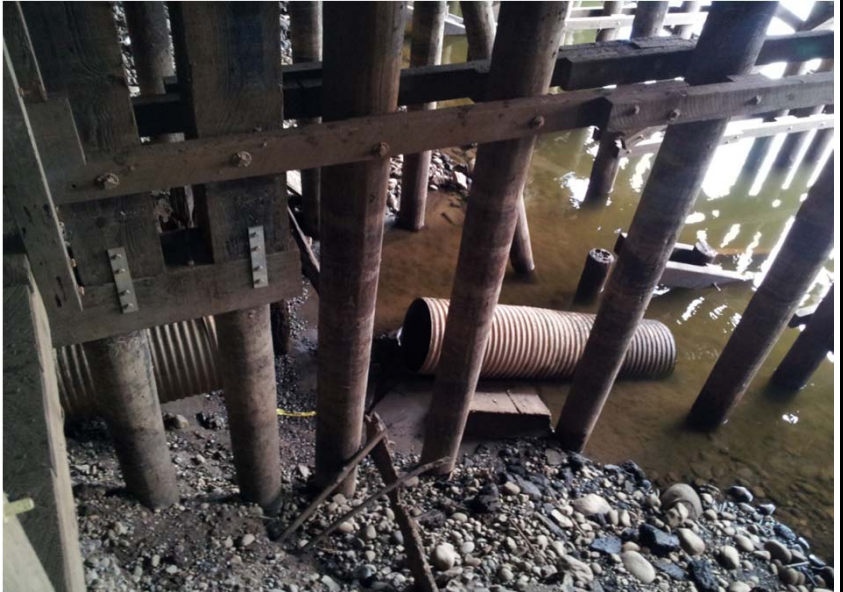
Photo No: 21

Photo Date: 8/22/2012	
Orientation: North	
Description: Feature AQ - Taken from inner catwalk. Disconnected section of outfall pipe in center right of photograph. Note small cove corresponding to outfall location.	
Photo No: 22

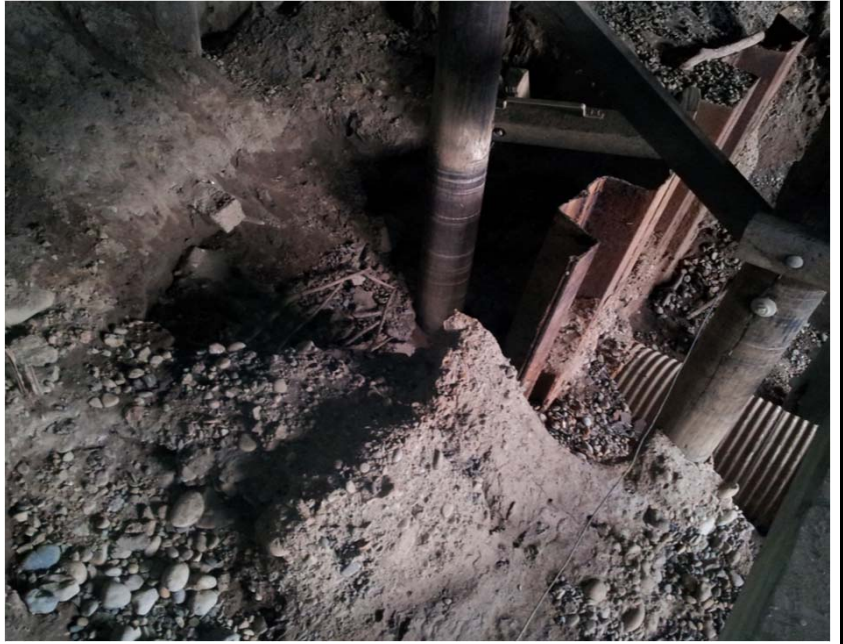
Photo Date: 8/22/2012	
Orientation: West	
Description: Feature AQ - Taken from inner catwalk. Scarp and bare soil upslope of outfall pipe around sheet pile wall.

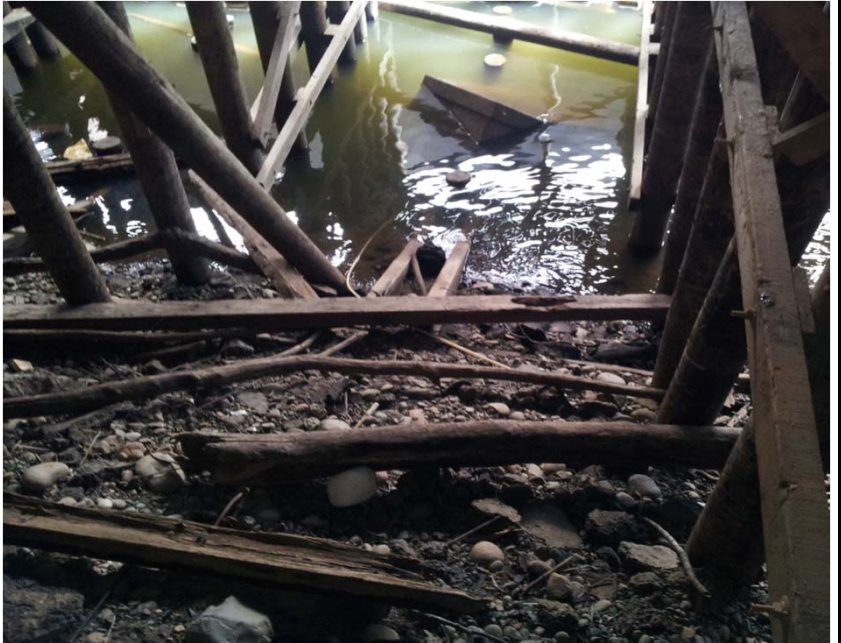
Photo No: 23

docks. Only the angled support beams are still visible (Photograph 23). Areas of specific observations are presented below. The OLHW was approximated by measuring down from the dock structure using a stadia rod.

Photo Date: 8/24/2012	
Orientation: Northeast	
Description: Typical view toward river.

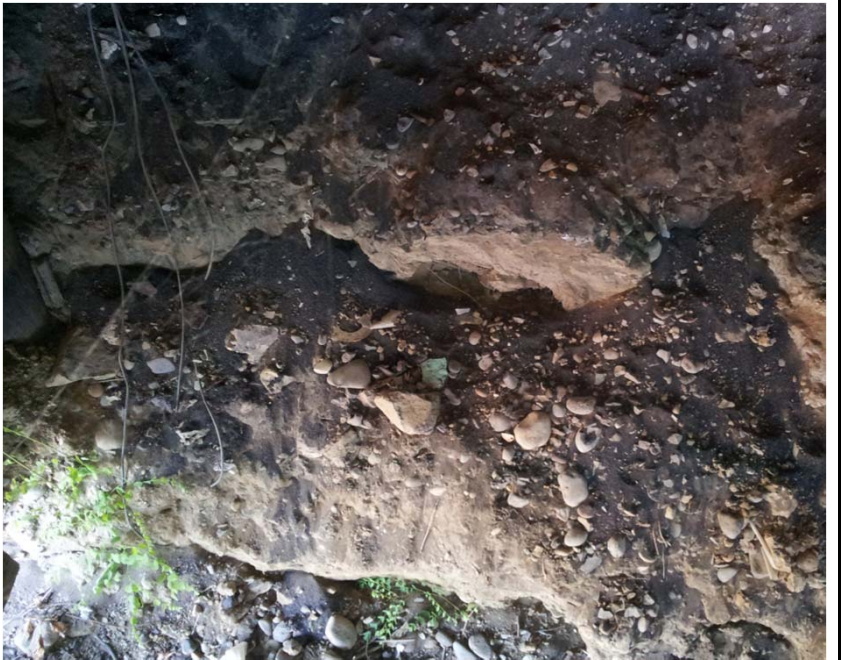
Photo No: 24

- AT – Bare soil. Flat bench at top of riverbank extending approximately 5 to 10 feet from edge of riverbank to back sheet-pile bulkhead.
- AU – Erosion scarps. Erosional scarps comprised of sand with overlying black grit. Sample OU1-RB19 was collected from the face of this slope.

Photo Date: 8/22/2012	
Orientation: Southwest	
Description: Feature AU

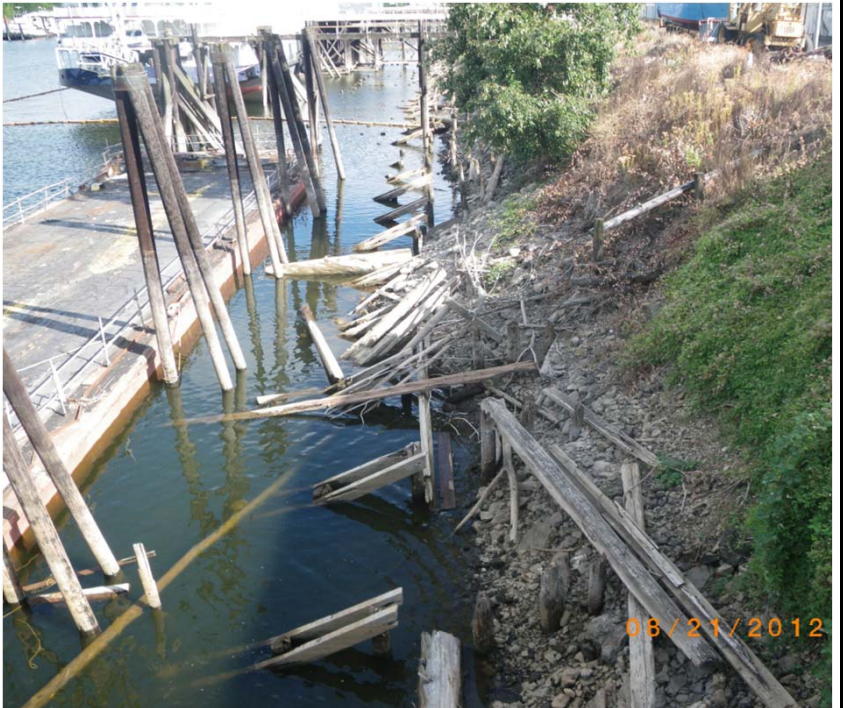
Photo No: 25

Photo Date: 8/21/2012	
Orientation: Southeast	
Description: Feature AU - This feature is located under the outfall pipe in the upper right of the photograph. A section of this outfall pipe was observed on the riverbank further east.

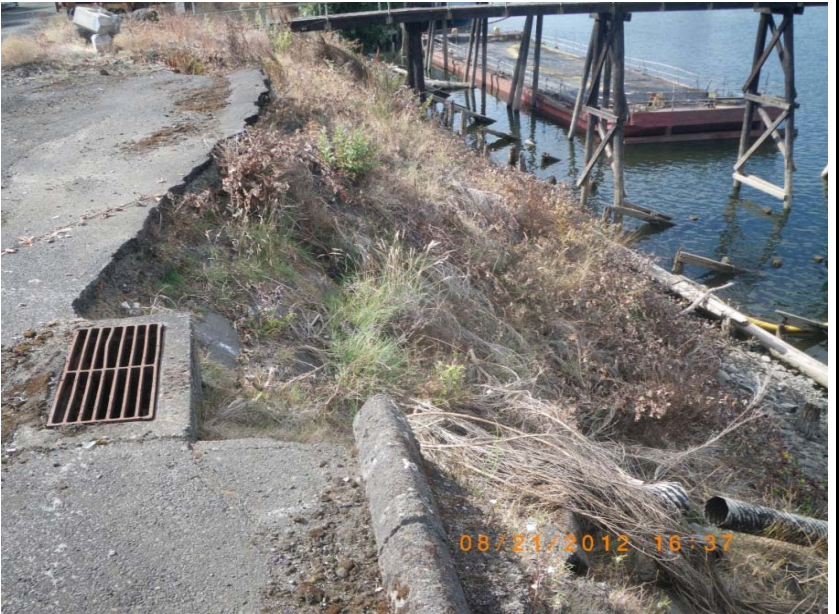
Photo No: 28

- AX – Bare soil. Bare soil on riverbank above OLHW with some vegetative cover and occasional concrete blocks and debris.
- AY – Erosion scarps. Series of erosional scarps present on riverbank at and above OLHW in the vicinity of an outfall. The outfall pipe has become disconnected and water discharges near the top of the slope. The scarps are approximately 10 feet high and vary in length from 10 to 30 feet. Sample OU1-RB2 was collected from one of the larger features at this location.

Photo Date: 8/20/2012	
Orientation: Northwest	
Description: Feature AY - Erosion along top of riverbank as indicated by rough edge of asphalt-concrete adjacent to catch basin. Note the segments of the outfall pipe that are disconnected in the lower right of the phtograph. See also photograph 29.

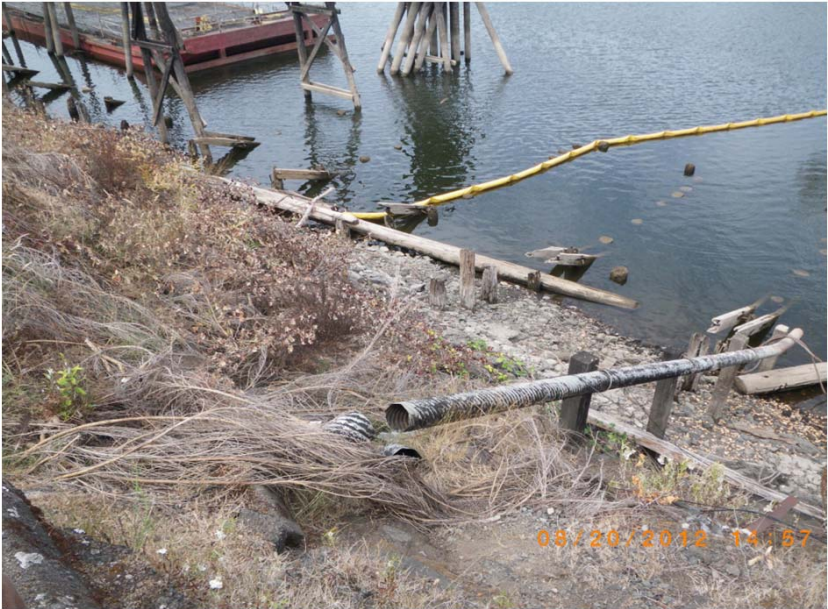
Photo No: 29

Photo Date: 8/20/2012	
Orientation: Northwest	
Description: Feature AY - Riverbank under disconnection segments of outfall pipe.
